Aerial UAS Drone Roofing Inspection and Analytics Report

Report date:
Jan 27, 2018

Roof Inspection

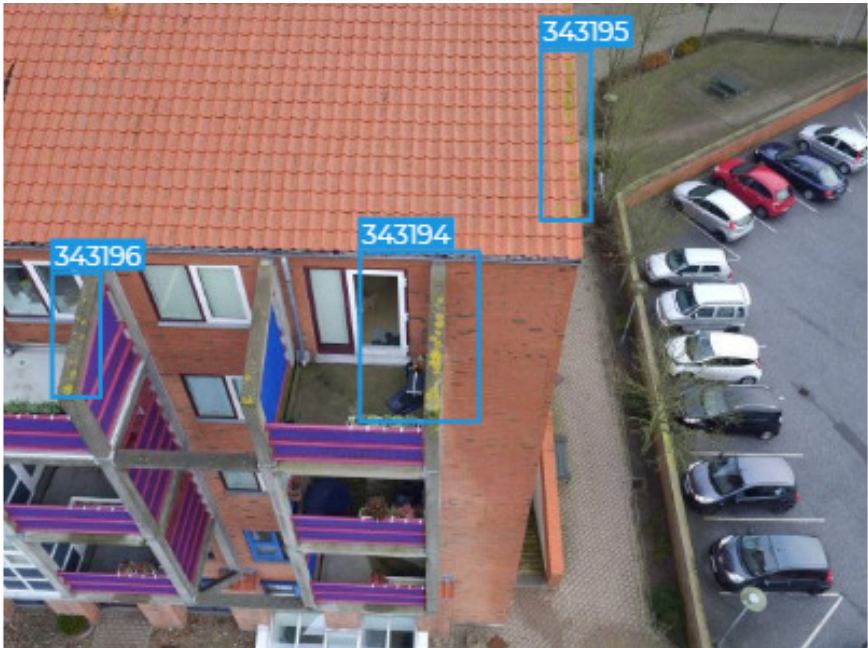
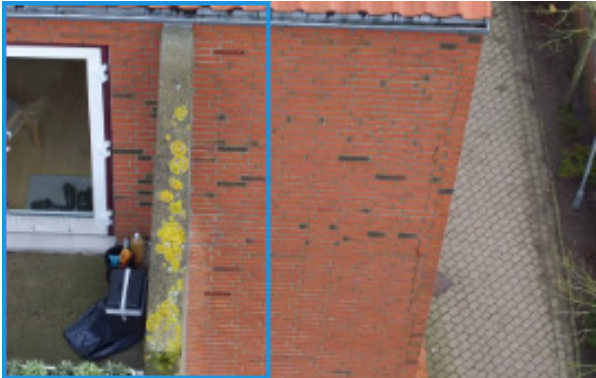
File name:	0001.jpg	Altitude:	23.6m
Date taken:	Feb 10, 2016 5:49:08 AM	Heading:	Northeast (53.6°)
Position:

343194 Point of interest Moss Accumulation

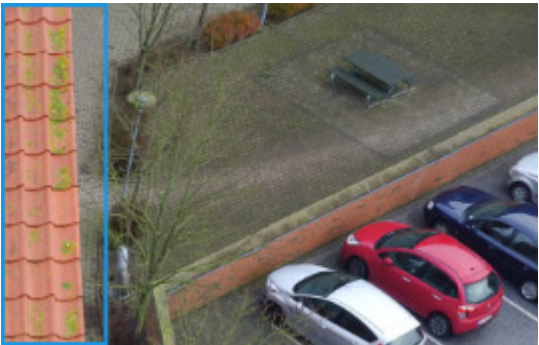
343195 Point of interest Moss Accumulation

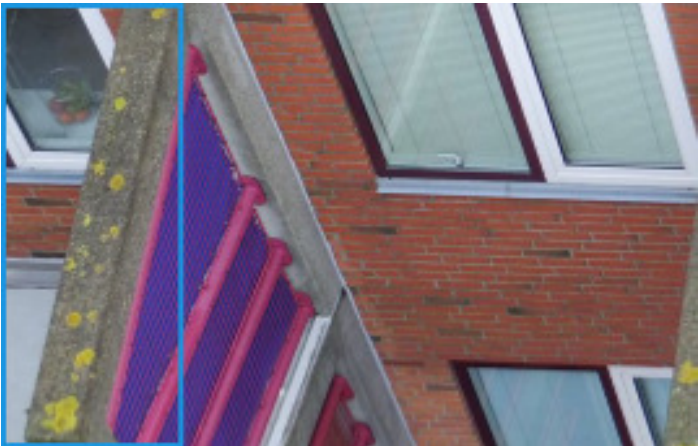
343196 Point of interest Moss Accumulation

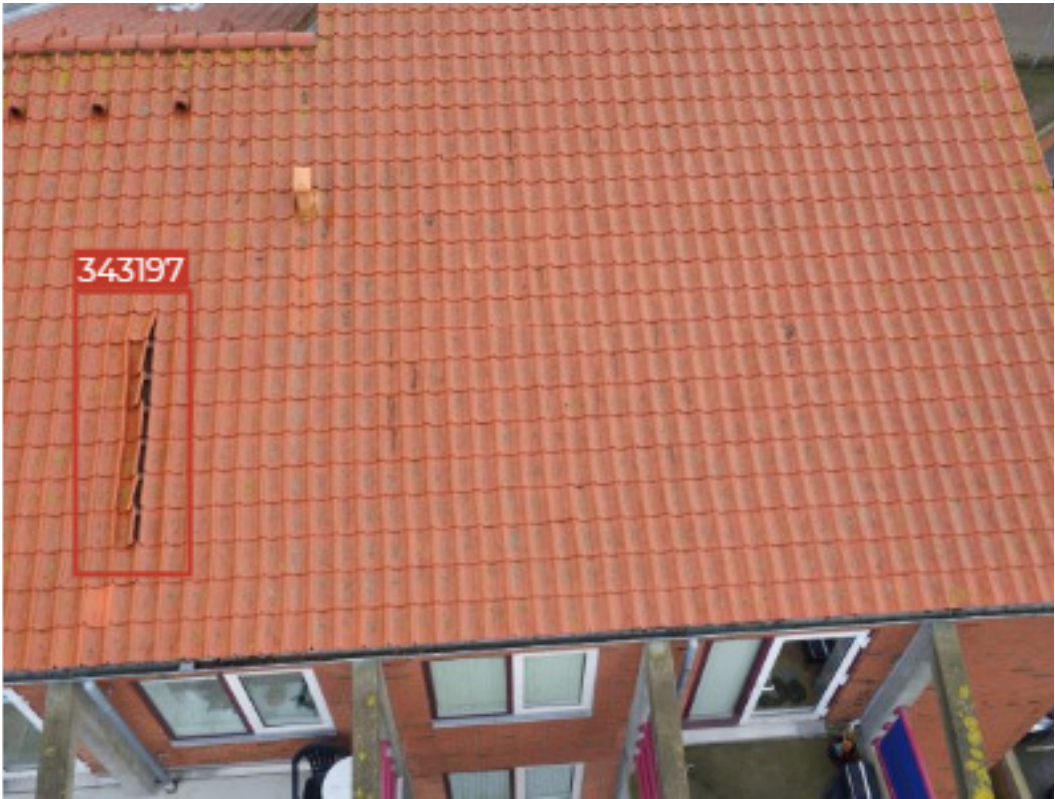
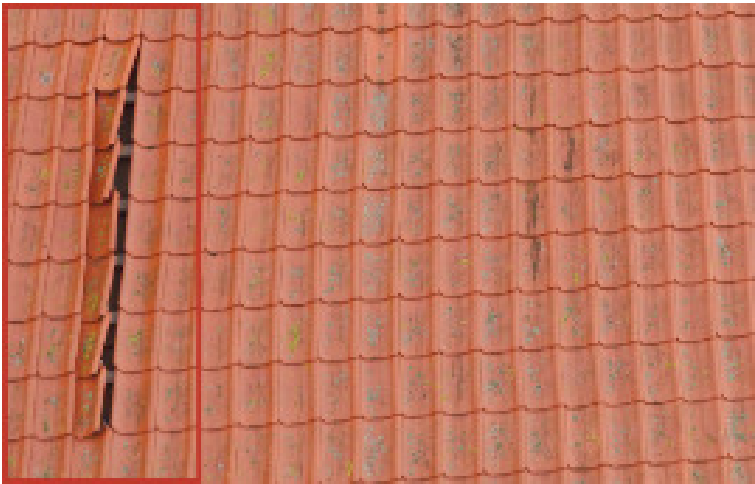
File name:	0008.jpg	Altitude:	23.5m
Date taken:	Feb 10, 2016 5:49:53 AM	Heading:	Northeast (57.9°)
Position:

343197 Severity: 5 Broken tile

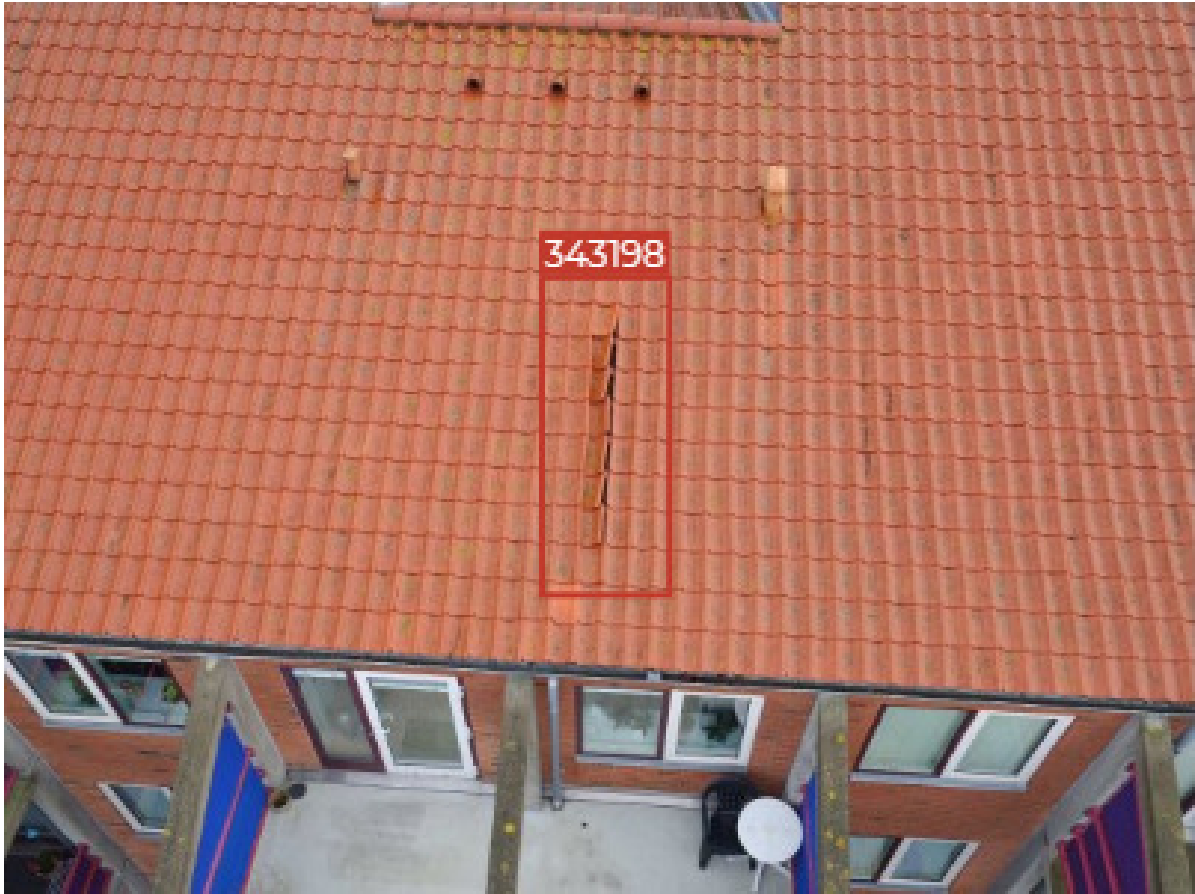
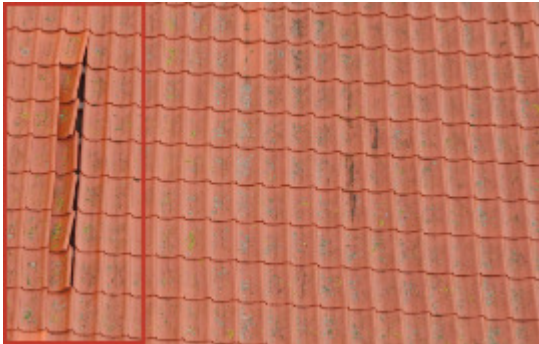
File name:	0010.jpg	Altitude:	23.5m
Date taken:	Feb 10, 2016 5:50:03 AM	Heading:	Northeast (47.9°)
Position:

343198 Severity: 5 Broken tile

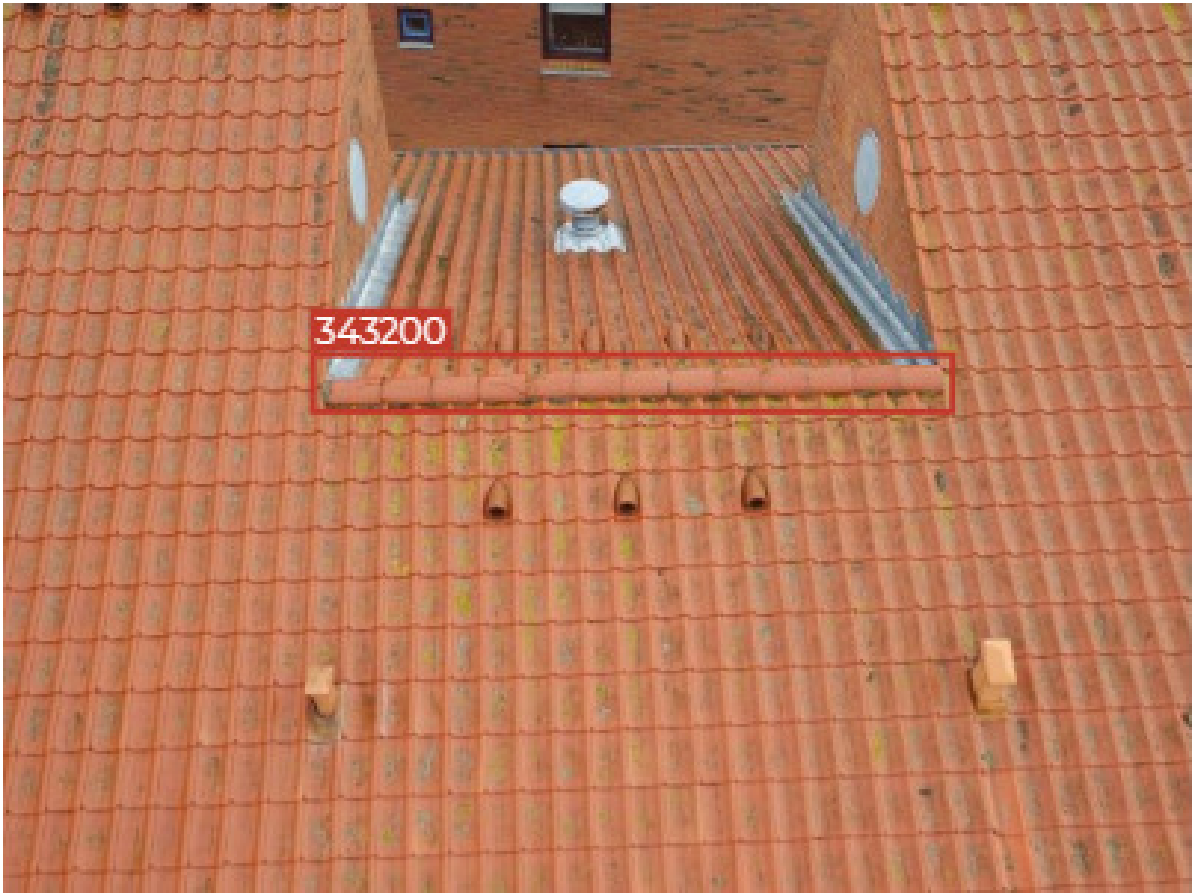
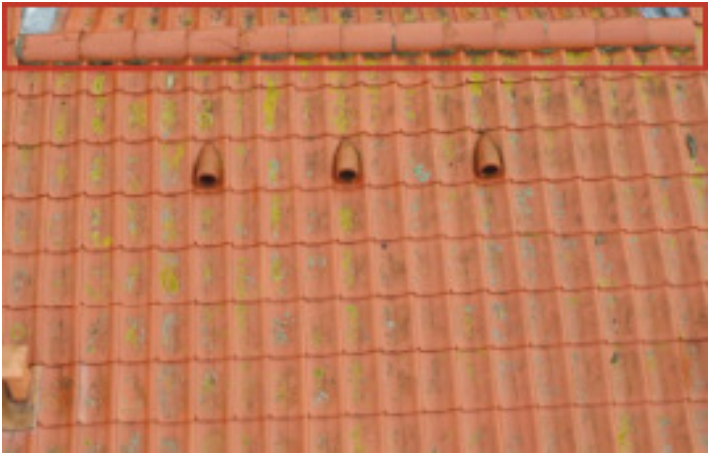
File name:	0009.jpg	Altitude:	23.4m
Date taken:	Feb 10, 2016 5:50:11 AM	Heading:	Northeast (55.4°)
Position:

Img. 0009.jpg: Has fractured tiles on roof peak, not displaced yet.

343200 Severity: 5 Broken tile

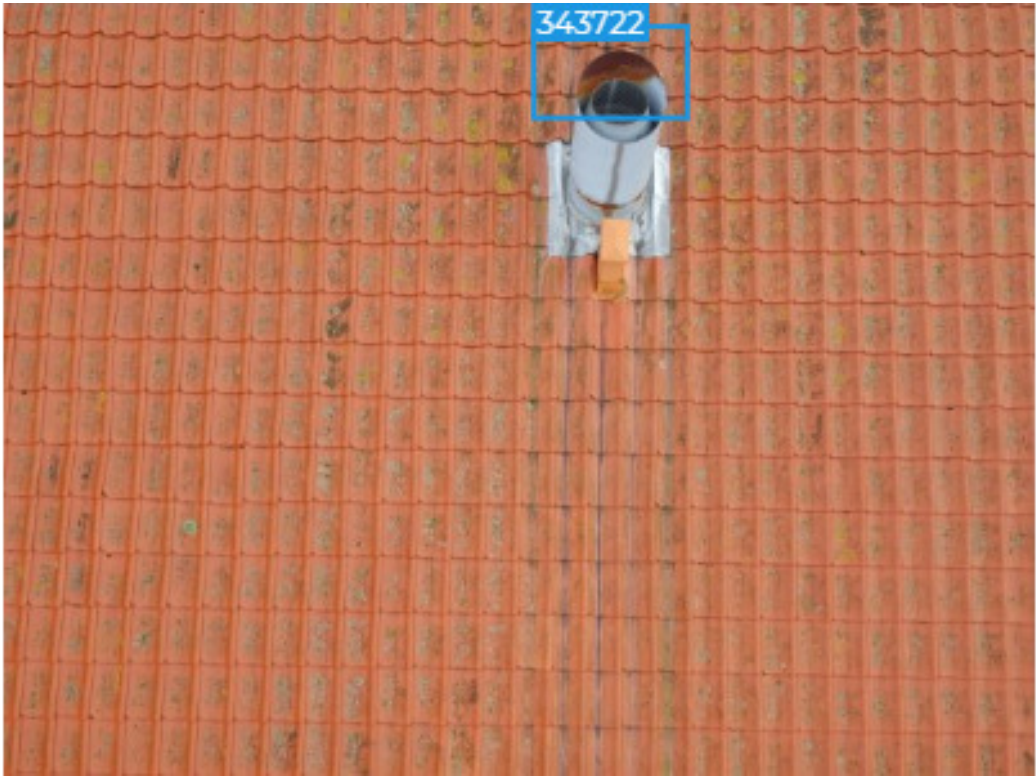
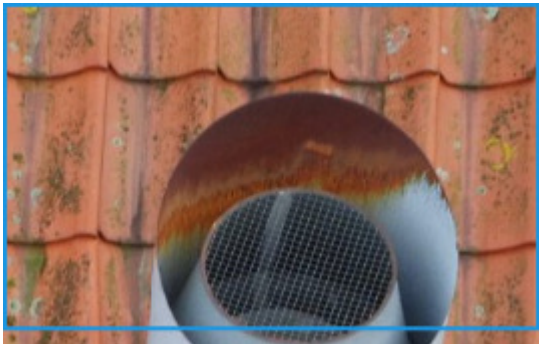
File name:	0022.jpg	Altitude:	23.1m
Date taken:	Feb 10, 2016 5:51:37 AM	Heading:	Northeast (52.6°)
Position:

343722 Point of interest Rusted Chimney Pipe

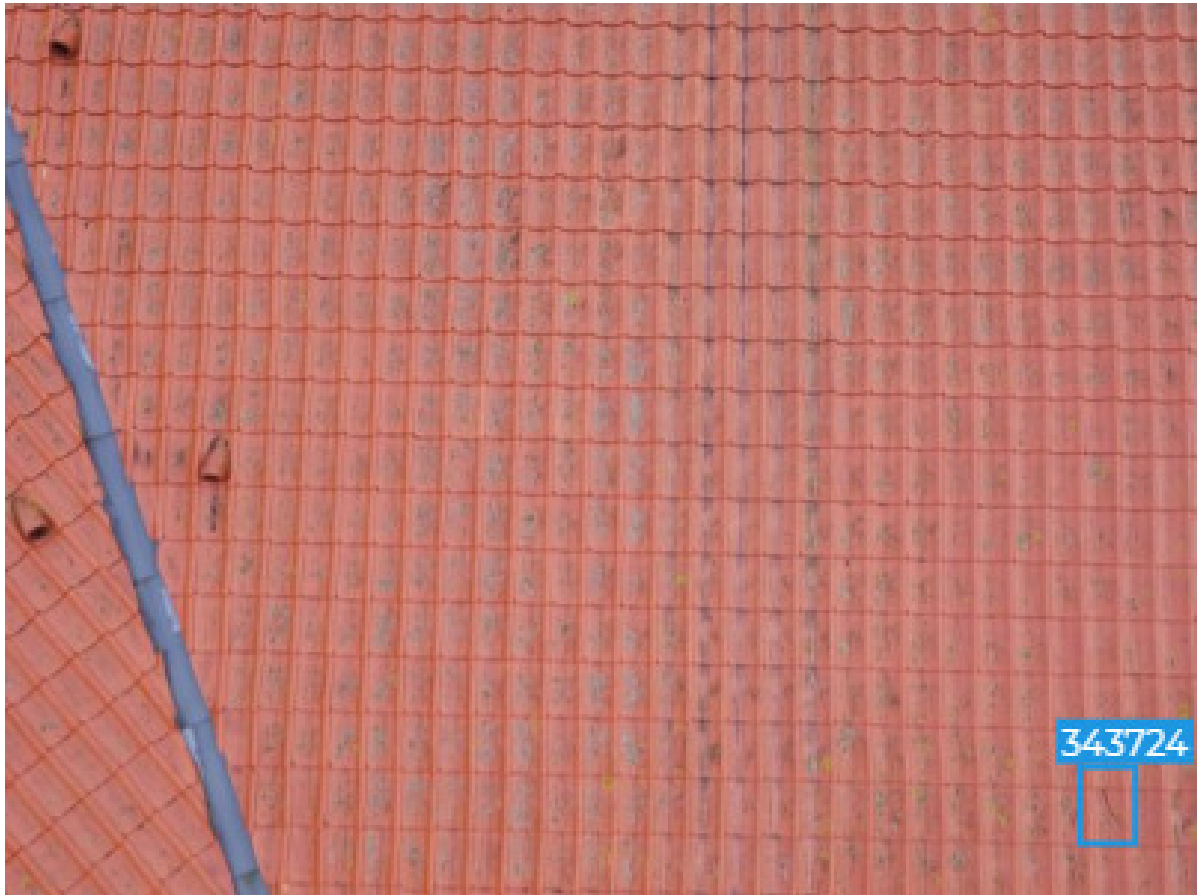
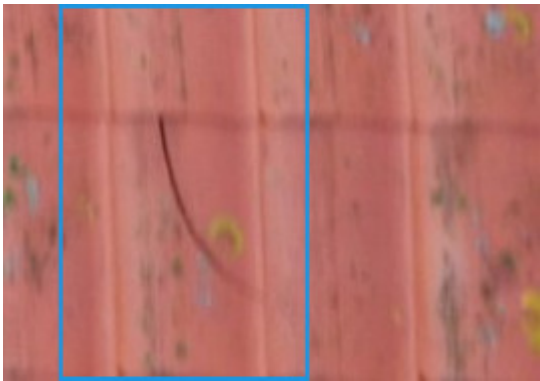
File name:	0021.jpg	Altitude:	23.2m
Date taken:	Feb 10, 2016 5:51:41 AM	Heading:	Northeast (52.6°)
Position:

343724 Point of interest Broken tile

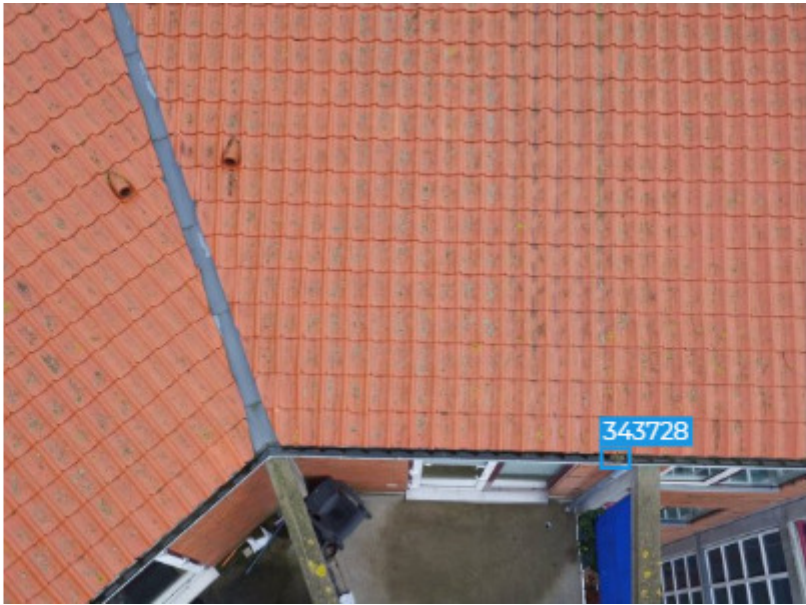
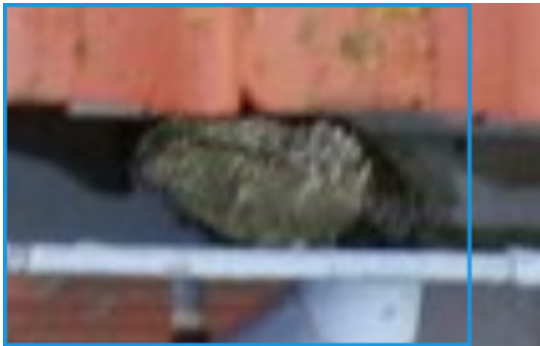
File name:	0023.jpg	Altitude:	23.2m
Date taken:	Feb 10, 2016 5:51:44 AM	Heading:	Northeast (52.6°)
Position:

343728 Point of interest Debris

Curtis Marshall:
Causing water flow issue

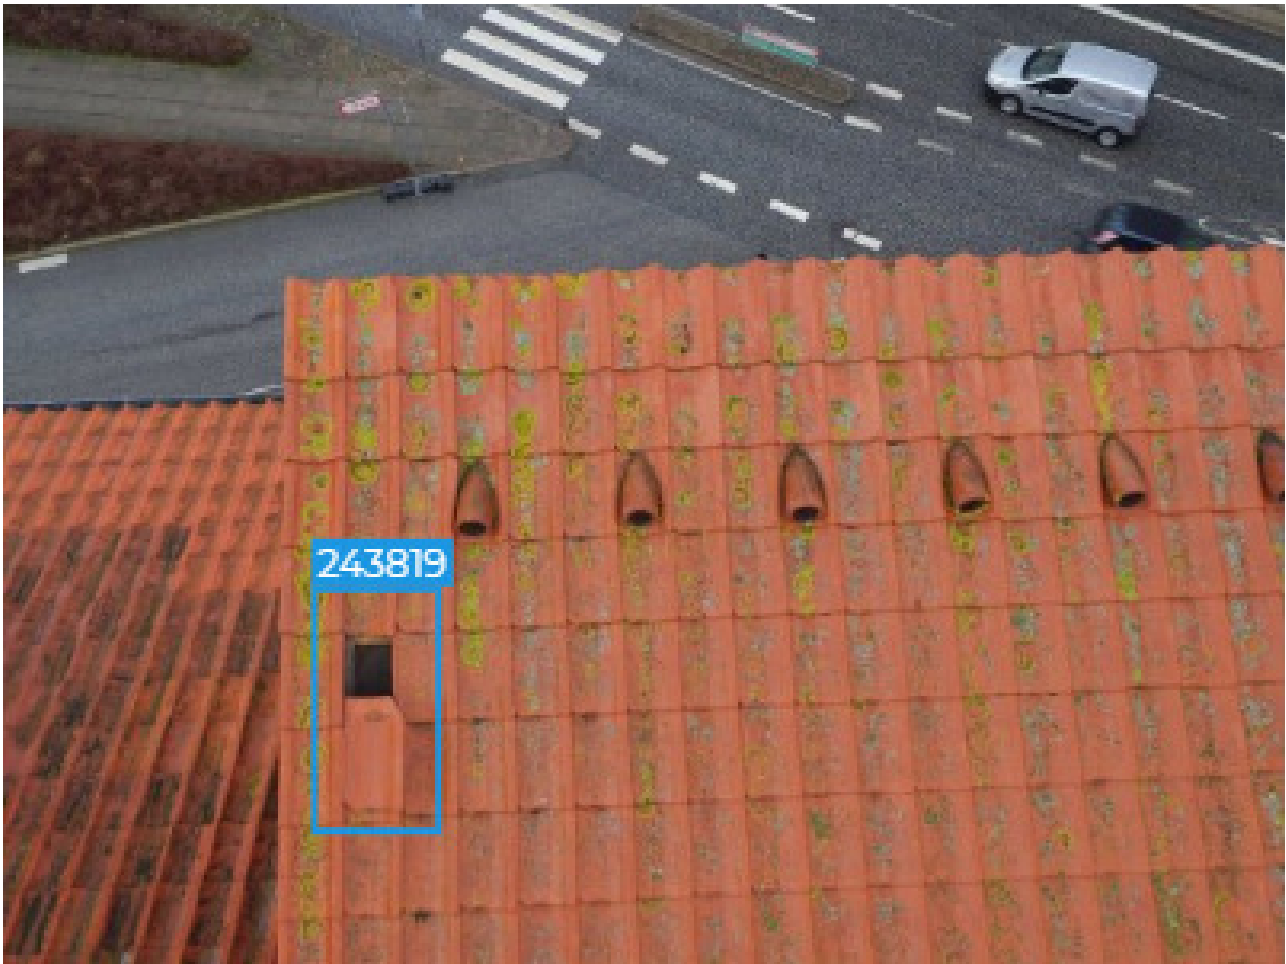
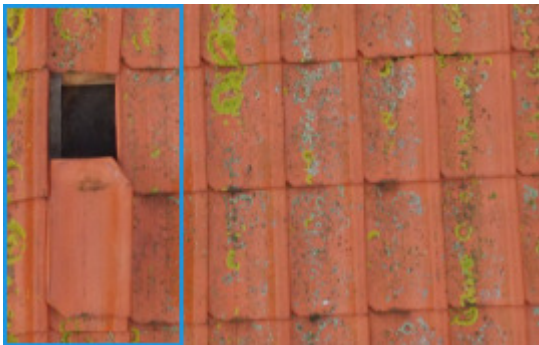
File name:	0114.jpg	Altitude:	25.1m
Date taken:	Feb 10, 2016 6:10:17 AM	Heading:	Northwest (326.2°)
Position:

Img. 0114.jpg: Displaced tile, needs attention.

243819 Point of interest Loose tile
